WATER BALANCE STUDY FOR A WATER-EFFICIENT LANDSCAPE SYSTEM AT THE ENVIRONMENTAL CENTER OF THE ROCKIES WATER YEAR 1999

PREPARED BY: WRIGHT WATER ENGINEERS, INC.
2490 WEST 26TH AVENUE, SUITE 100A
DENVER, CO 80211-4208

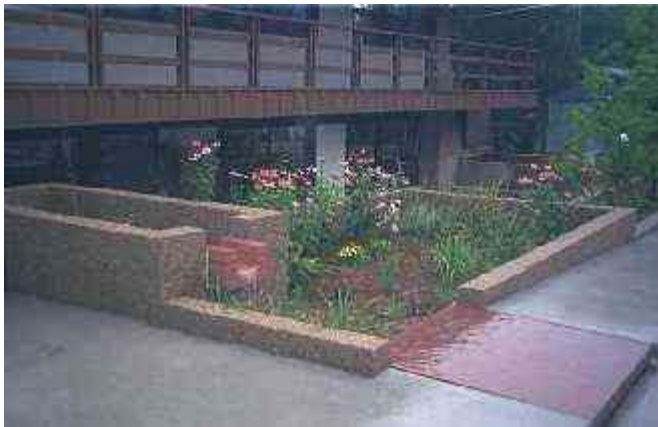
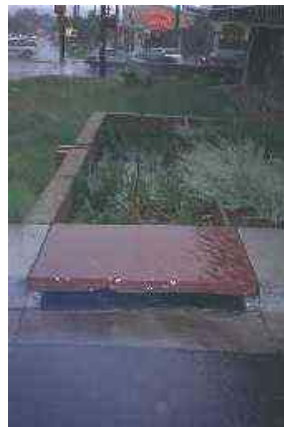
Rear Planter & Catch Pond— Photo ©Len Wright
